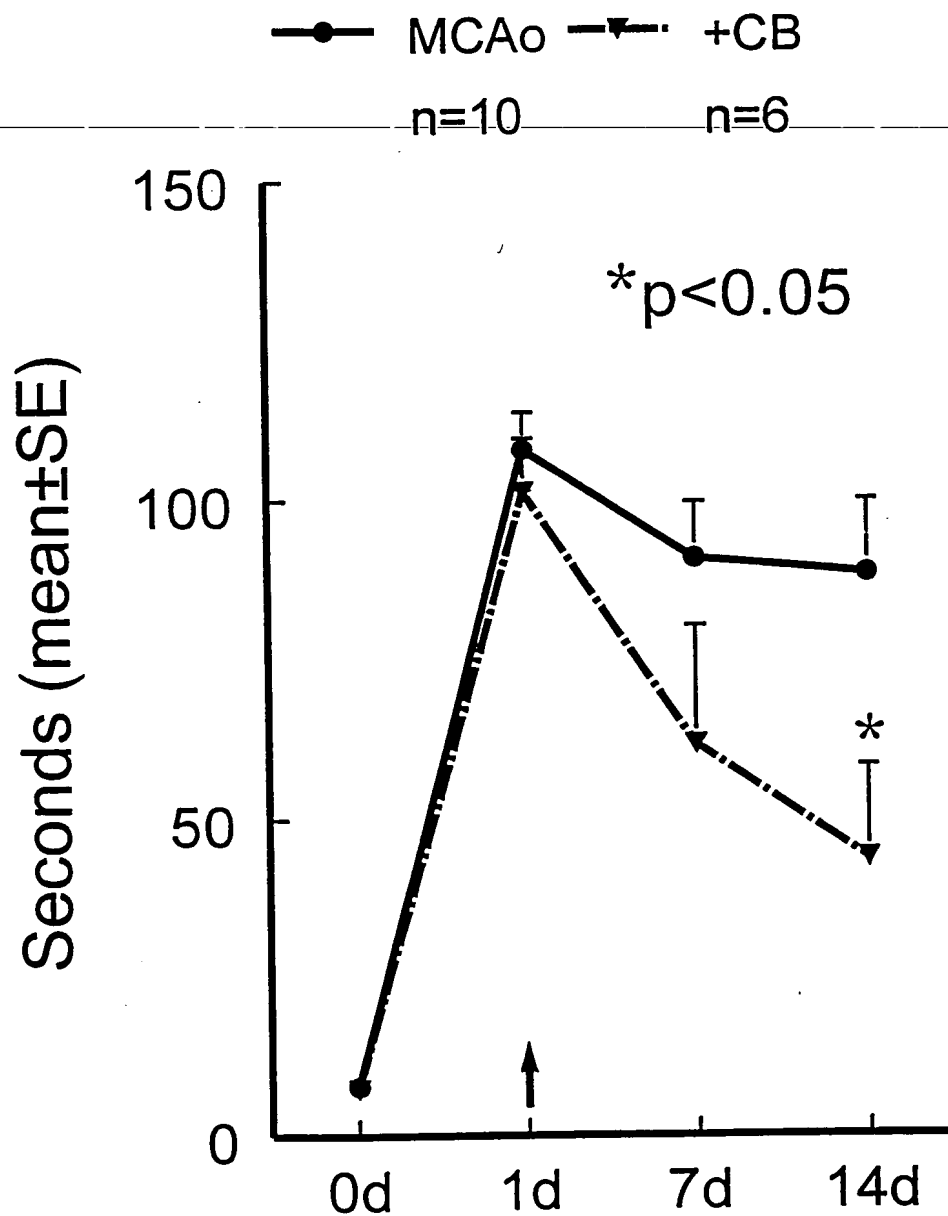
Figure 3A

Adhesive-Removal Test

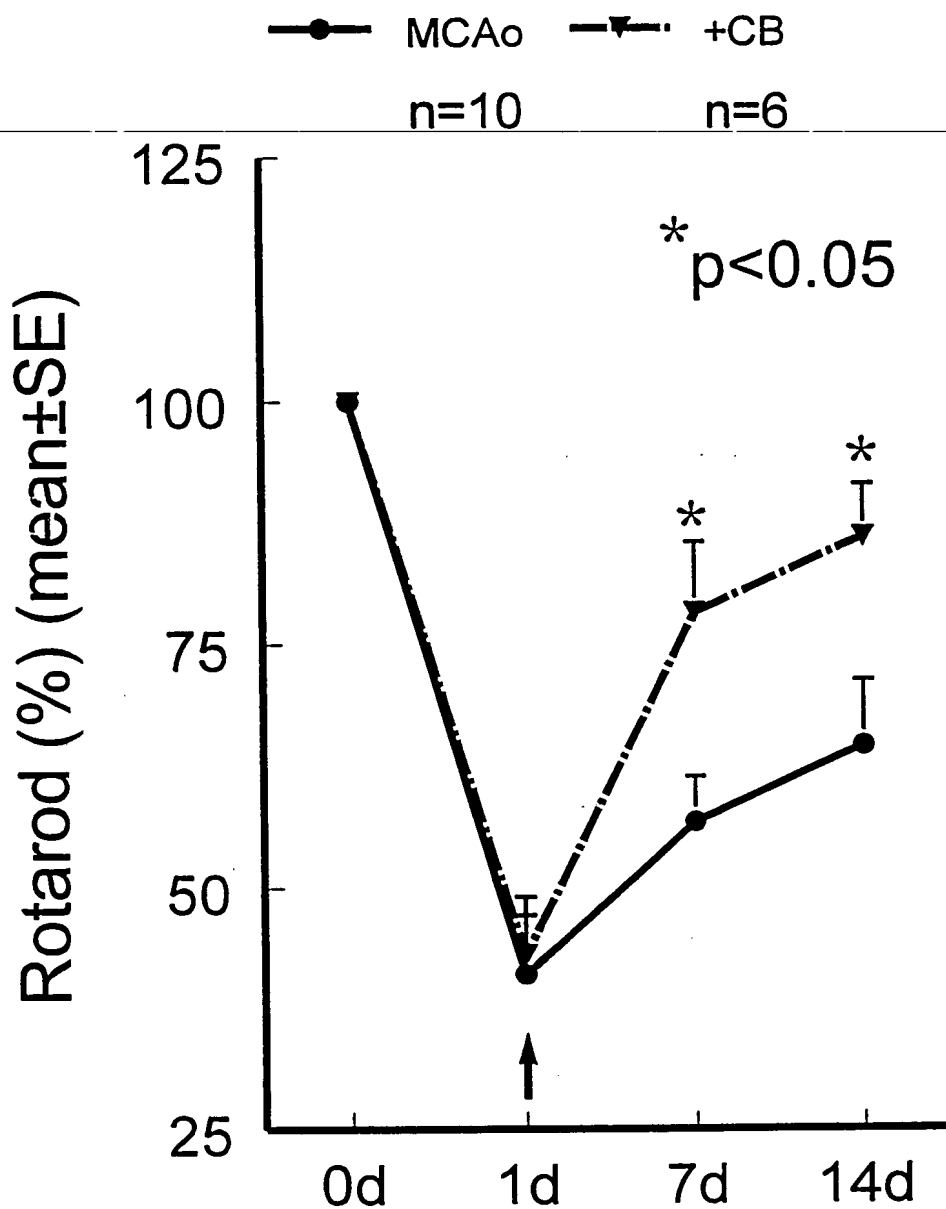
Figure 3B

Motor Test

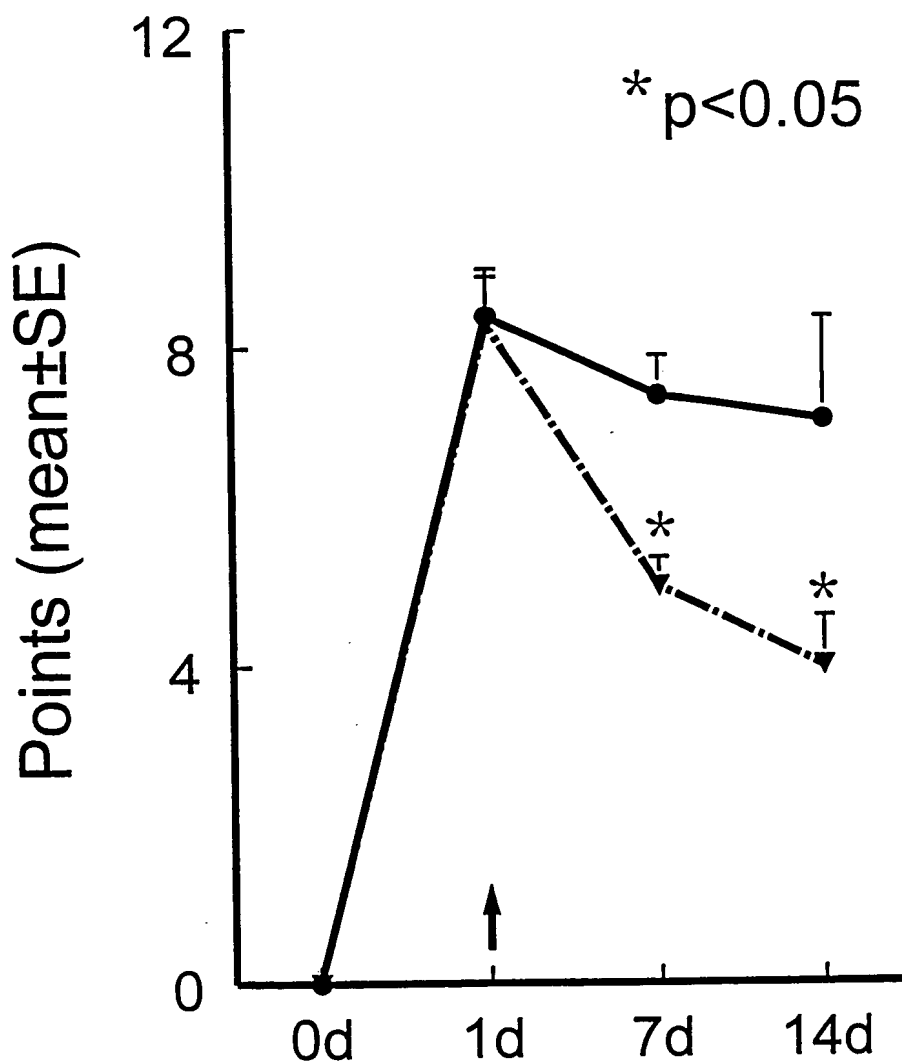
Figure 3C

mNSS Test

—●— MCAo —▼— +CB
n=10 n=6

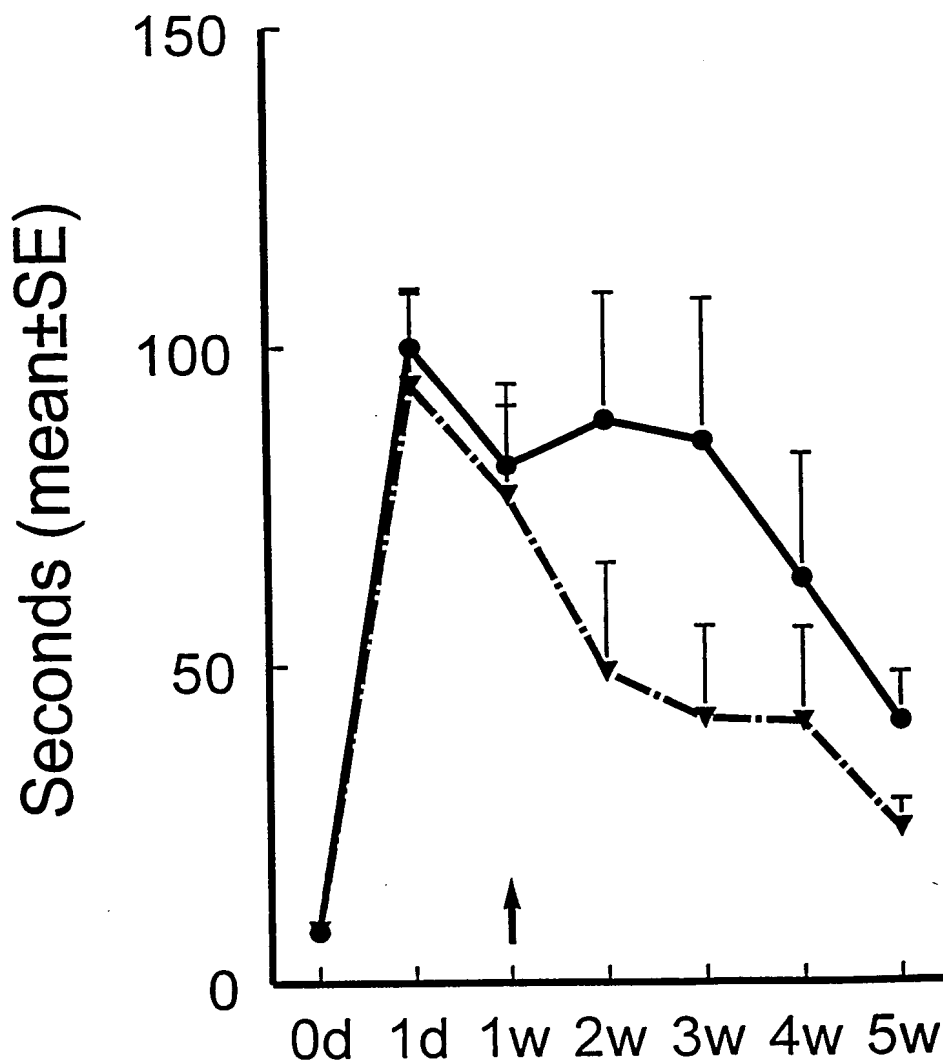
Figure 4A

Adhesive-Removal Test

—●— MCAo —▼— +CB
n=5 n=5

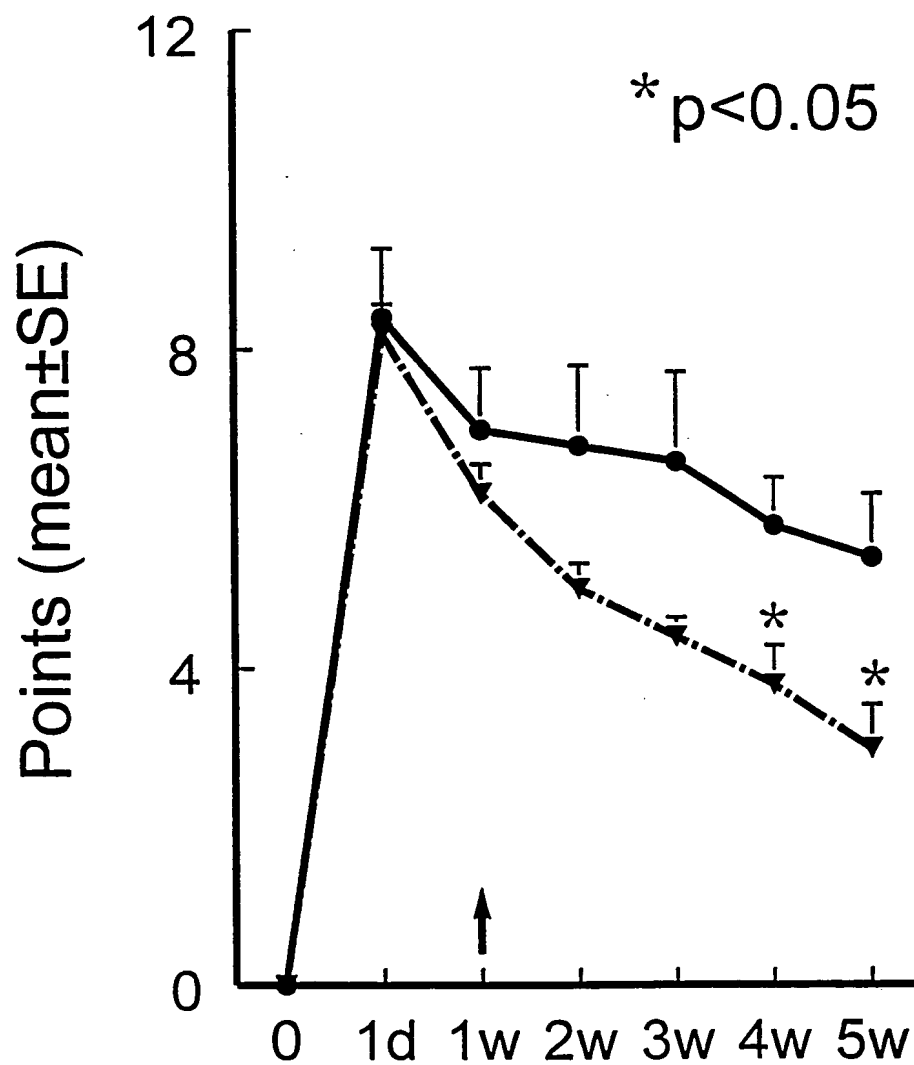
● FIGURE 4C ●

mNSS Test

—●— MCAo —▼— +CB
n=5 n=5
